PIP breast implants: rupture rate and correlation with breast cancer

M. MOSCHETTA¹, M. TELEGRAFO¹, I. CORNACCHIA¹, L. VINCENTI², V. RANIERI²,
A. CIRILLI², L. RELLA¹, A.A. STABILE IANORA¹, G. ANGELELLI¹

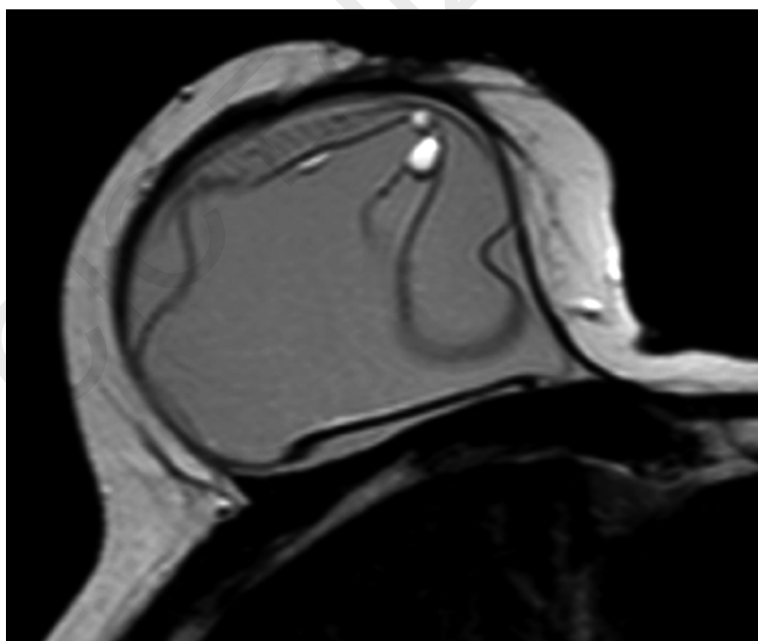
Fig. 1 - PIP implant with intra-capsular rupture detected at TSE-T2 MR sequence and represented by "linguine sign".

By using both MR images and intra-prosthetic virtual navigation, 20 out of the 40 (50%) PIP implants presented signs of intra-capsular rupture: linguine sign in 20 cases (100%) (Figure 1), tear-drop sign in 6 (30%). A peri-prosthetic fluid effusion was also detected in all cases. In 12 out of 20 cases (60%), MRI signs of extra-capsular rupture represented by siliconomas and silicone dissemination to axillary and internal mammary lymph nodes were detected (Figure 2).

“teardrop” sign, “keyhole” sign and “sub-capsular line” sign. The “linguine sign” consists of curvilinear hypointense lines within the hyper-intense silicone filled implant. It is due to the collapse of the implant shell in silicone gel and it represents the most reliable sign of intra-capsular rupture.

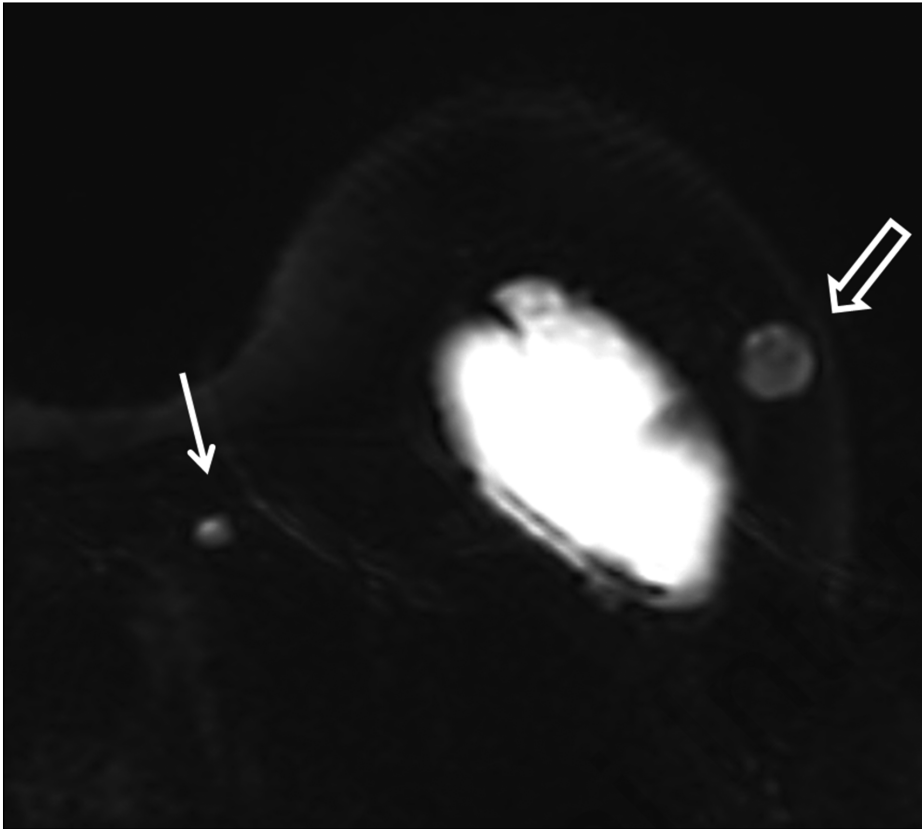
Fig. 2 - PIP implant with extra-capsular rupture detected at silicone-only MR sequence and represented by free peri-prosthetic silicone particles (empty arrow) and within an internal mammary lymph node (arrow).

On the other side, the diagnosis of extra-capsular rupture relies on the detection of free silicone particles outside the implant, within the breast glandular tissue or the axillary or mammary lymph nodes. In our series, the linguine sign has been confirmed to be the most common MR sign of implant rupture.
